## 急傾斜地の崩壊区域調書

様式5-4 危害のおそれのある土地等の座標位置図

| 急傾斜地の位置 | 箇所番号 | I-031K2078 | 箇所名 | 小根本1 | 所在地 | 松戸市小根本、岩瀬 |

様式5-5 危害のおそれのある土地の座標一覧(1/3)

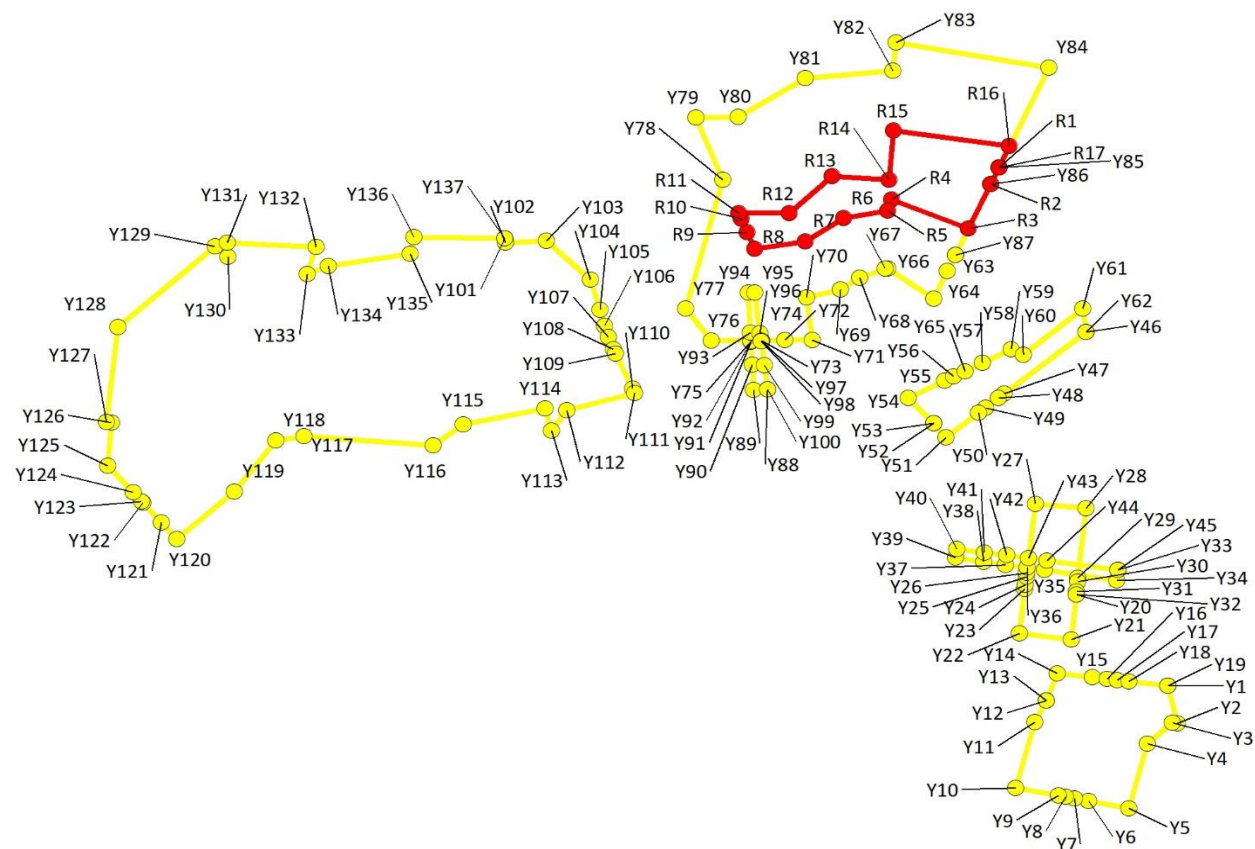
1:1,500

平面直角座標系: 第Ⅸ系(測地成果2011)
