# 急傾斜地の崩壊区域調査

様式5-4 危害のおそれのある土地等の座標位置図

II-123K2086

小田代22

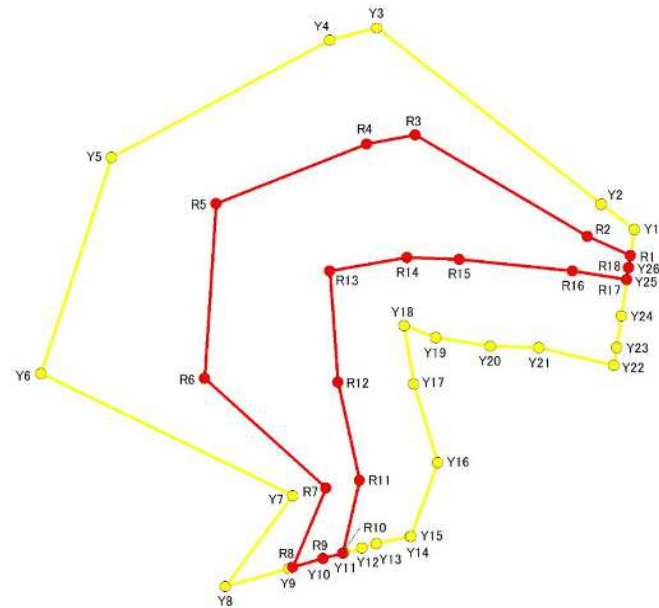
1:1,500
