# 急傾斜地の崩壊区域調査

様式5-4 危害のおそれのある土地等の座標位置図

II-123K2227

平沢29

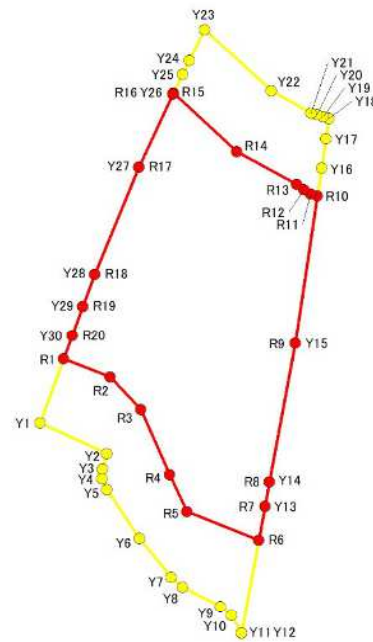
1:1,500

平面直角座標系: 第Ⅸ系(測地成果2011)
