# 急傾斜地の崩壊区域調書

様式5-4 危害のおそれのある土地等の座標位置図

I-031K2039

秋山1

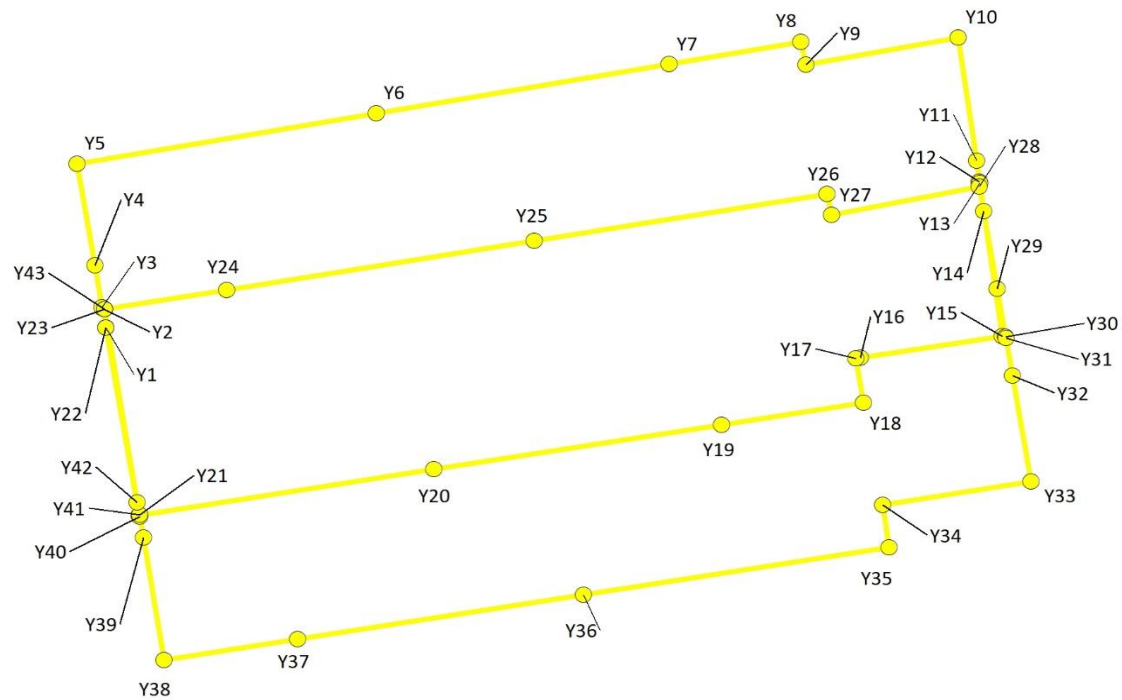
1:500
