様式5-5 危害のおそれのある土地等の座標一覧

急傾斜地の位置	箇所番号	<i>I −042K2086(−1)</i>	箇所名	<i>緑2</i>	所在地	我孫子市緑1丁目、緑2丁目

急 傾 斜 地 の 崩 壊 区 域 調 書

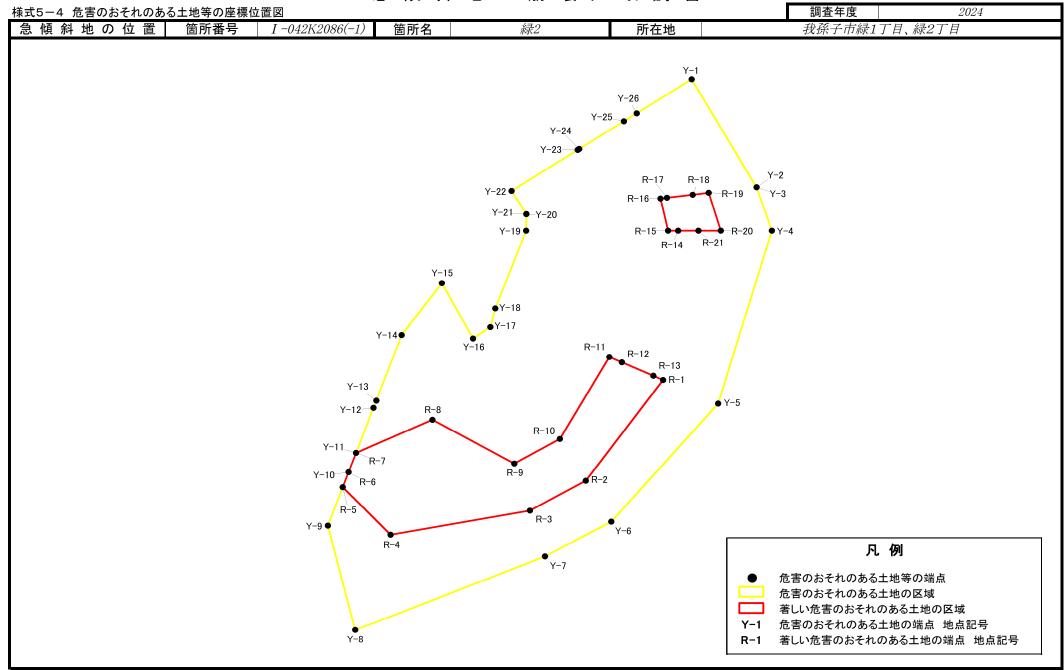
危 [:]	害のおそれの	ある土地の座	標	
地点記号	X(m)	Y(m)	地点記号	X(m)	Y(m)
Y-1	-14593.49	16554.67			
Y-2	-14607.4	16562.72			
Y-3	-14607.4	16562.72			
Y-4	-14613.01	16564.63			
Y-5	-14635.36	16557.96			
Y-6	-14650.58	16544.68			
Y-7	-14655.07	16536.44			
Y-8	-14664.6	16512.87			
Y-9	-14651.09	16509.47			
Y-10	-14644.21	16512.05			
Y-11	-14641.72	16512.97			
Y-12	-14635.91	16515.14			
Y-13	-14634.99	16515.49			
Y-14	-14626.54	16518.64			
Y-15	-14619.78	16523.63			
Y-16	-14626.99	16527.5			
Y-17	-14625.51	16529.66			
Y-18	-14623.07	16530.27			
Y-19	-14613.01	16534.1			
Y-20	-14610.89	16534.13			
Y-21	-14610.87	16534.13			
Y-22	-14607.87	16532.29			
Y-23	-14602.59	16540.5			
Y-24	-14602.47	16540.7			
Y-25	-14598.9	16546.25			
Y-26	-14597.88	16547.84

著しい	危害のおそれ	ιのある土地の)座標	
地点記号	X(m)	Y(m)	地点記号	X(m)	Y(m)
R-1	-14632.32	16551.12			
R-2	-14645.31	16541.52			
R-3	-14649.16	16534.56			
R-4	-14652.26	16517.27			
R-5	-14646.14	16511.32			
R-6	-14644.21	16512.05			
R-7	-14641.72	16512.97			
R-8	-14637.46	16522.46			
R-9	-14643.09	16532.63			
R-10	-14639.93	16538.29			
R-11	-14629.35	16544.44			
R-12	-14630.04	16545.99			
R-13	-14631.78	16549.9			
R-14	-14613.01	16552.98			
R-15	-14613.01	16551.74			
R-16	-14608.85	16550.8			
R-17	-14608.75	16551.60			
R-18	-14608.37	16554.79			
R-19	-14608.12	16556.78			
R-20	-14613.01	16558.28			
R-21	-14613.01	16555.51

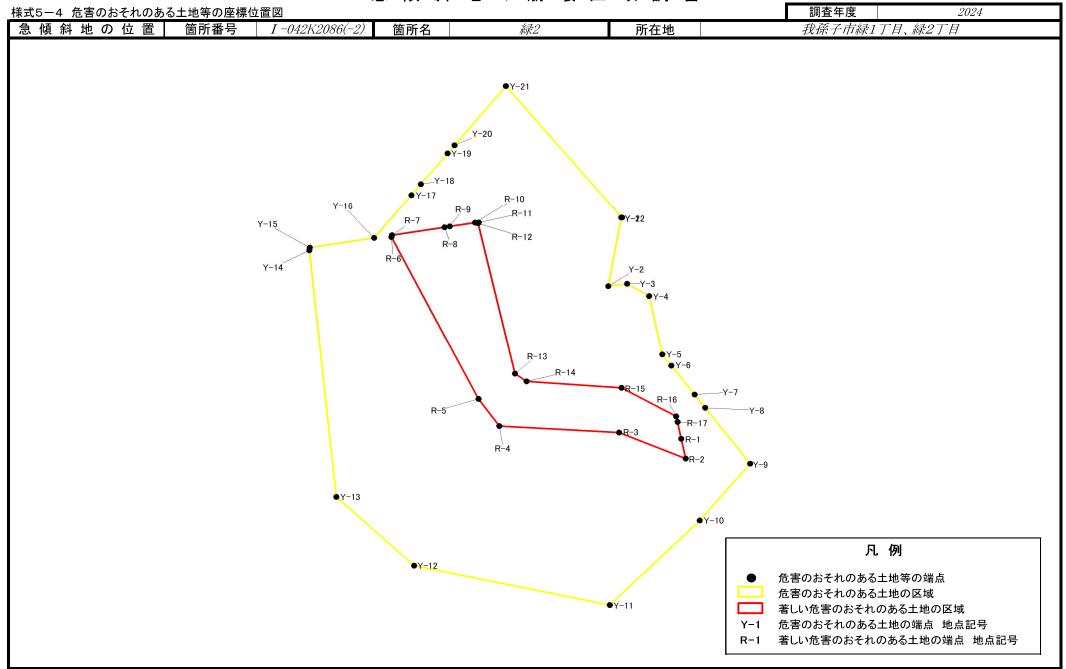
急傾斜地の位置	箇所番号	I -042K2086(-2)	箇所名	緑2	所在地	我孫子市緑1丁目、緑2丁目

危	害のおそれの	ある土地の座	標	
地点記号	X(m)	Y(m)	地点記号	X(m)	Y(m)
Y-1	16354.43	-14710.05			
Y-2	16353	-14717.9			
Y-3	16355.07	-14717.63			
Y-4	16357.5	-14719.03			
Y-5	16358.94	-14725.74			
Y-6	16359.94	-14727.03			
Y-7	16362.5	-14730.35			
Y-8	16363.67	-14731.86			
Y-9	16368.62	-14738.26			
Y-10	16363.06	-14744.83			
Y-11	16353.17	-14754.51			
Y-12	16331.63	-14750			
Y-13	16323.07	-14742.13			
Y-14	16320.1	-14713.81			
Y-15	16320.14	-14713.49			
Y-16	16327.23	-14712.38			
Y-17	16331.33	-14707.47			
Y-18	16332.37	-14706.21			
Y-19	16335.32	-14702.68			
Y-20	16336.08	-14701.76			
Y-21	16341.73	-14695			
Y-22	16354.51	-14710.05

地点記号	X(m)	Y(m)	地点記号	X(m)	Y(m)
R-1	16361.03	-14735.42			
R-2	16361.51	-14737.68			
R-3	16354.19	-14734.7			
R-4	16341.01	-14733.96			
R-5	16338.72	-14730.85			
R-6	16329.14	-14712.28			
R-7	16329.2	-14712.07			
R-8	16334.98	-14711.16			
R-9	16335.55	-14711.07			
R-10	16338.34	-14710.63			
R-11	16338.75	-14710.62			
R-12	16338.67	-14710.72			
R-13	16342.73	-14727.95			
R-14	16344	-14728.83			
R-15	16354.45	-14729.58			
R-16	16360.47	-14732.85			
R-17	16360.62	-14733.49

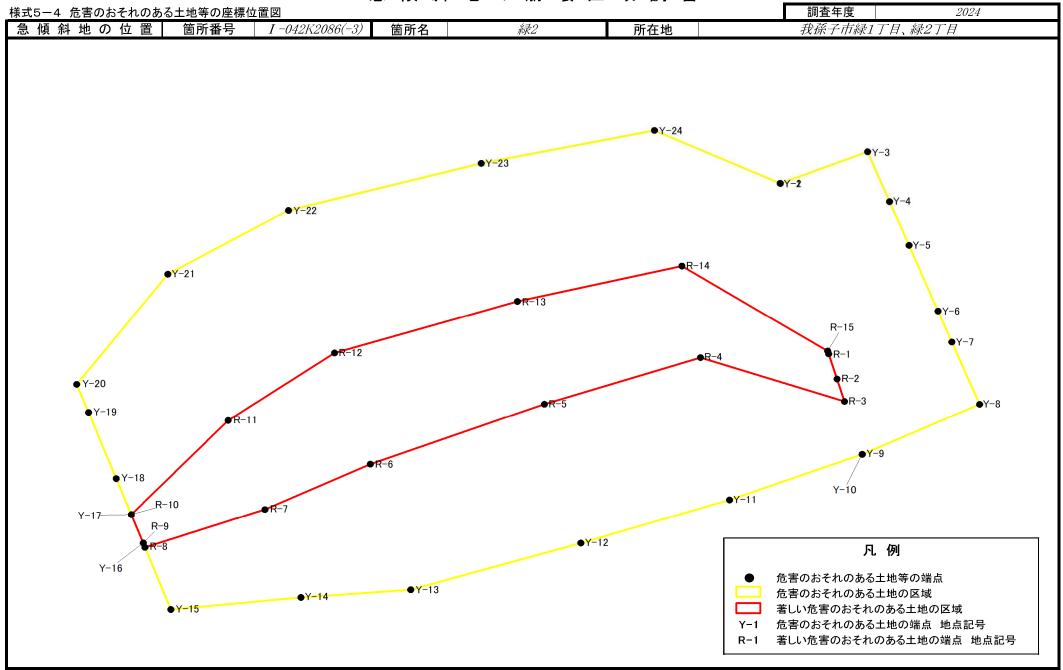
急傾斜地の位置	箇所番号	I -042K2086(-3)	箇所名	<i>緑2</i>	所在地	Ī	残孫子市緑1丁	目、緑2丁目

危	害のおそれの	ある土地の座	標	
地点記号	X(m)	Y(m)	地点記号	X(m)	Y(m)
Y-1	16442.9	-14687			
Y−2	16442.92	-14687.01			
Y-3	16451.15	-14683.91			
Y-4	16453.23	-14688.79			
Y-5	16455.07	-14693.11			
Y-6	16457.81	-14699.56			
Y-7	16459.12	-14702.62			
Y-8	16461.73	-14708.76			
Y-9	16450.66	-14713.7			
Y-10	16450.64	-14713.7			
Y-11	16438.12	-14718.18			
Y-12	16424.07	-14722.41			
Y-13	16408.01	-14726.96			
Y-14	16397.63	-14727.71			
Y-15	16385.35	-14728.89			
Y-16	16382.75	-14722.4			
Y-17	16381.62	-14719.61			
Y-18	16380.2	-14716.08			
Y-19	16377.58	-14709.56			
Y-20	16376.47	-14706.79			
Y-21	16385.06	-14695.93			
Y-22	16396.46	-14689.66			
Y-23	16414.67	-14685.04			
Y-24	16431.02	-14681.82

著しい	・・・・・・・・・・・・・・・・・・・・・・・・・・・・・・・・・・・・・	 ιのある土地 <i>0</i>	 D座標	
地点記号	X(m)	Y(m)	地点記号	X(m)	Y(m)
R-1	16447.48	-14703.79			
R-2	16448.26	-14706.26			
R-3	16448.97	-14708.47			
R-4	16435.38	-14704.15			
R-5	16420.64	-14708.75			
R-6	16404.2	-14714.66			
R-7	16394.24	-14719.12			
R-8	16382.91	-14722.83			
R-9	16382.75	-14722.4			
R-10	16381.62	-14719.61			
R-11	16390.77	-14710.36			
R-12	16400.81	-14703.7			
R-13	16418.08	-14698.61			
R-14	16433.62	-14695.14			
R−15	16447.39	-14703.51

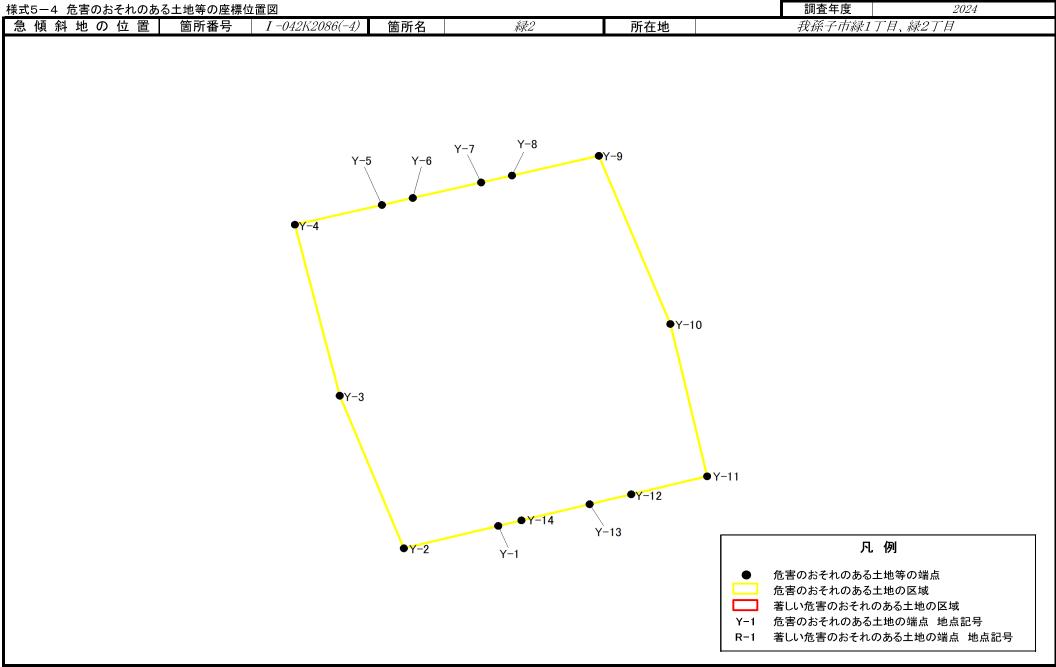
緑2

Y-1 Y-2 Y-3 Y-4 Y-5 Y-6 Y-7 Y-8 Y-9	X(m) 16434.45 16426.65 16421.36	害のおそれ Y(m) -14685 -14687.1	のある土地の座地点記号	E標 X(m)	Y(m
Y-1 Y-2 Y-3 Y-4 Y-5 Y-6 Y-7 Y-8 Y-9 Y-10 Y-11 Y-12 Y-13	X(m) 16434.45 16426.65 16421.36	Y(m) -14685	地点記号	1	Y(m
Y-1 Y-2 Y-3 Y-4 Y-5 Y-6 Y-7 Y-8 Y-9 Y-10 Y-11 Y-12 Y-13	16434.45 16426.65 16421.36	-14685	—		
Y-3 Y-4 Y-5 Y-6 Y-7 Y-8 Y-9 Y-10 Y-11 Y-12 Y-13	16421.36	-14687.1	.Z		
Y-4 Y-5 Y-6 Y-7 Y-8 Y-9 Y-10 Y-11 Y-12 Y-13			2		
Y-5 Y-6 Y-7 Y-8 Y-9 Y-10 Y-11 Y-12 Y-13		-14674.0	04		
Y-6 Y-7 Y-8 Y-9 Y-10 Y-11 Y-12 Y-13	16417.65	-14659.2	19		
Y-7 Y-8 Y-9 Y-10 Y-11 Y-12 Y-13	16424.84	-14657.5	i9		
Y-8 Y-9 Y-10 Y-11 Y-12 Y-13	16427.39	-14656.9	9		
Y-9 Y-10 Y-11 Y-12 Y-13	16433.03	-14655.6	66		
Y-10 Y-11 Y-12 Y-13	16435.58	-14655.C	06		
Y-11 Y-12 Y-13	16442.76	-14653.3	36		
Y-12 Y-13	16448.66	-14667.8	34		
Y-13	16451.7	-14680.9	5		
	16445.43	-14682	.5		
Y-14	16441.99	-14683.3	34		
	16436.36	-14684.7	' 3

・・・・・・・・・・・・・・・・・・・・・・・・・・・・・・・・・・・・・	ıのある土地 <i>の</i>)座標	
地点記号	X(m)	Y(m)	地点記号	X(m)	Y(m)
	X(111)	1 (111)	26.86.7	X(III)	1 (111)
