# 急傾斜地の崩壊区域調書

様式5-4 危害のおそれのある土地等の座標位置図

I-071K2289-1

大崎12

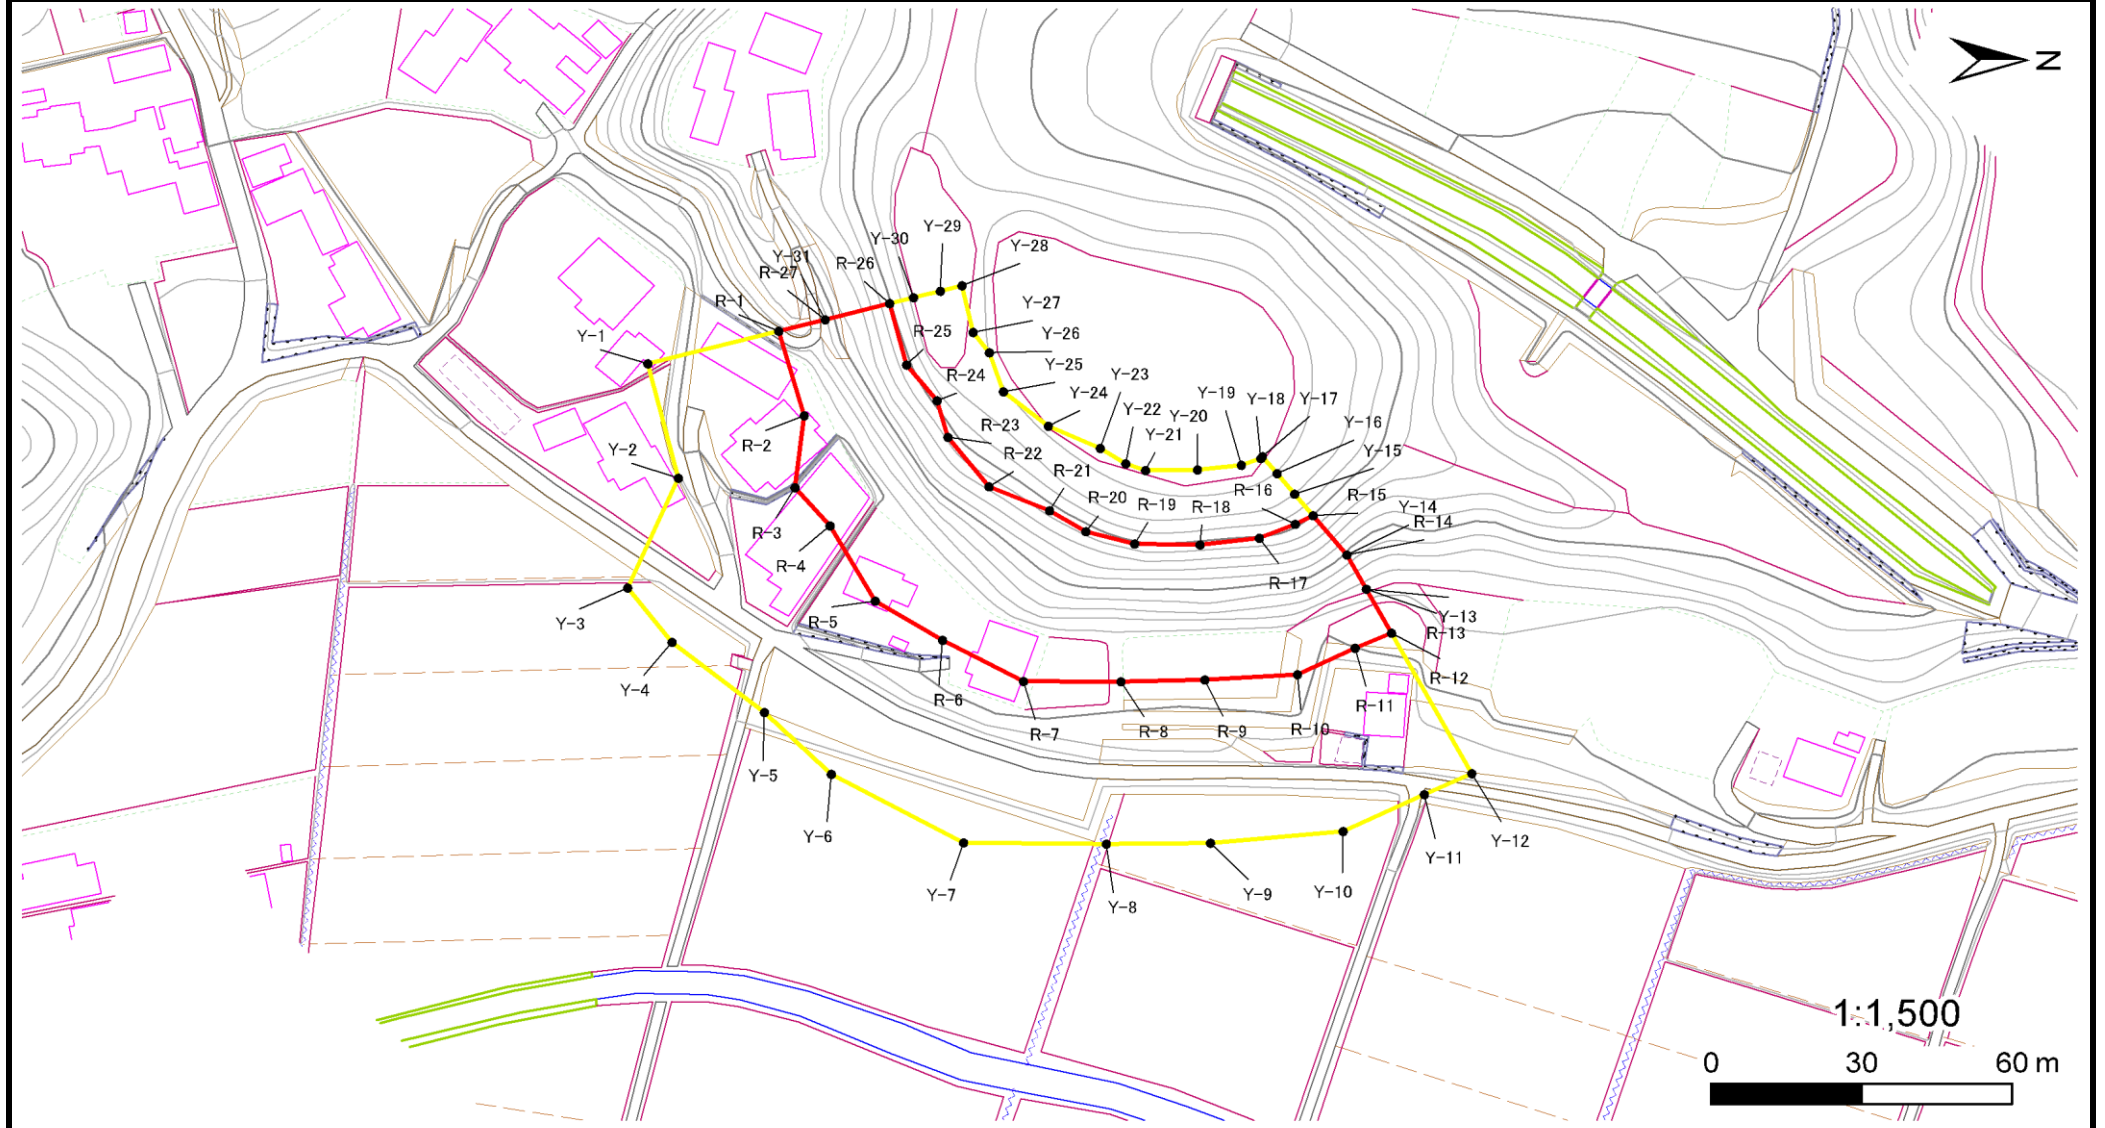
香取市大崎
