急傾斜地の崩壊区域調査

様式5-1 危害のおそれのある土地等の座標位置図

| 急傾斜地の位置 | 箇所番号 | I-1420 | 箇所名 | 不入斗4 | 所在地 |

千葉県市原市不入斗

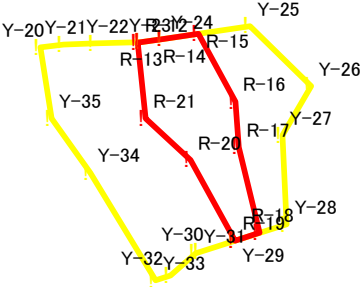
1:1,500

| 危害のおそれのある区域の座標(土砂災害警戒区域) | | | | | | 著しい危害のおそれのある区域の座標(土砂災害特別警戒区域) | | | | | |
