# 急傾斜地の崩壊区域調書

様式5-4 危害のおそれのある土地等の座標位置図

II-031K2040

秋山5

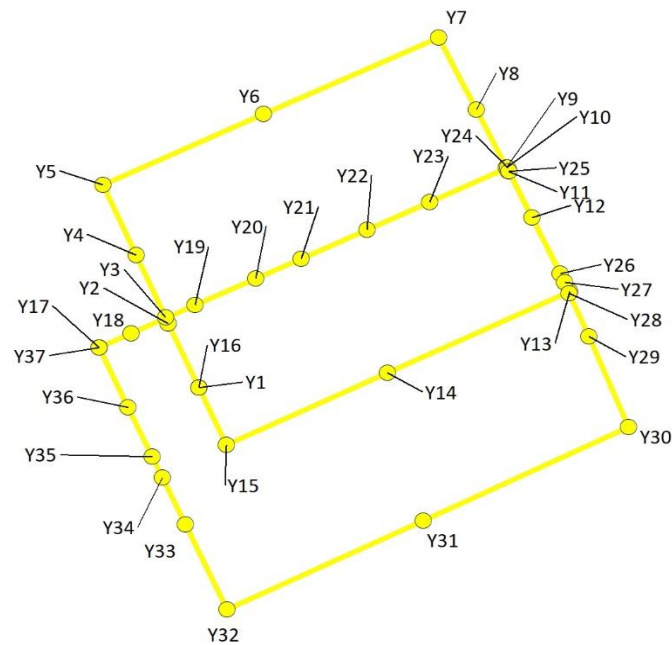
1:500
