急傾斜地の崩壊区域調書

様式5-4 危害のおそれのある土地等の座標位置図

急傾斜地の位置 箇所番号 II-054K2121-1 箇所名 大森12 所在地 印西市大森

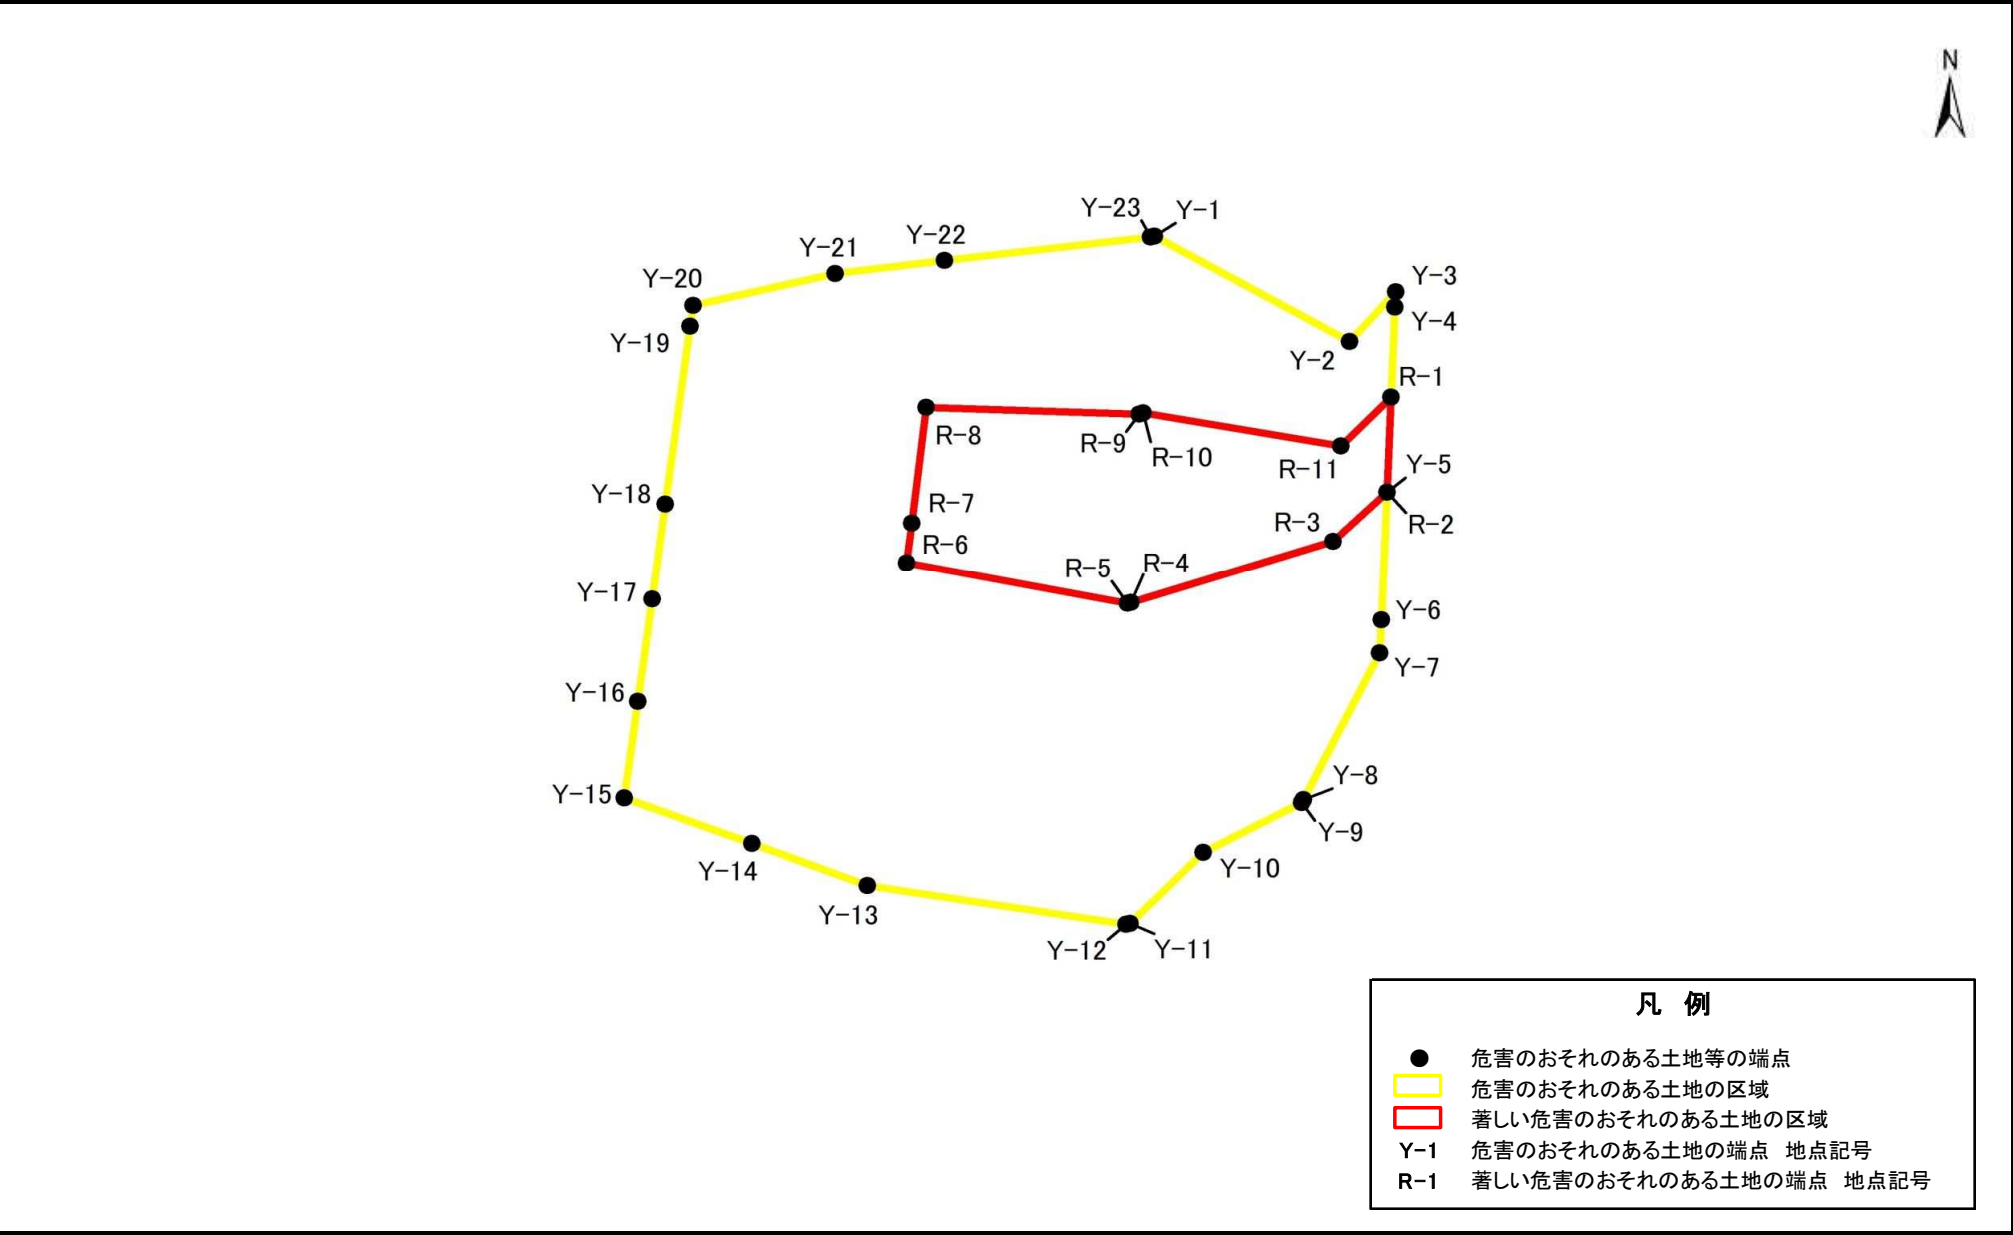
様式5-4 危害のおそれのある土地等の座標位置図

| 急傾斜地の位置 | 箇所番号 | II-054K2121-2 | 箇所名 | 大森12 | 所在地 | 印西市大森 |
