急傾斜地の崩壊区域調書

様式5-4 危害のおそれのある土地等の座標位置図

II-061K2019

伊能33

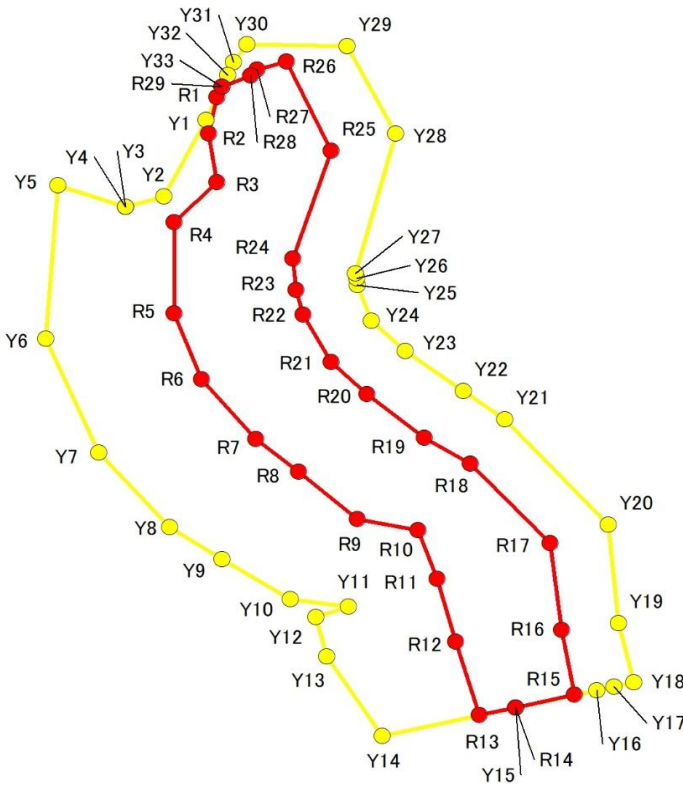
1:2,000
