急傾斜地の崩壊区域調書

様式5-4 危害のおそれのある土地等の座標位置図

II-061K2038

一坪田23

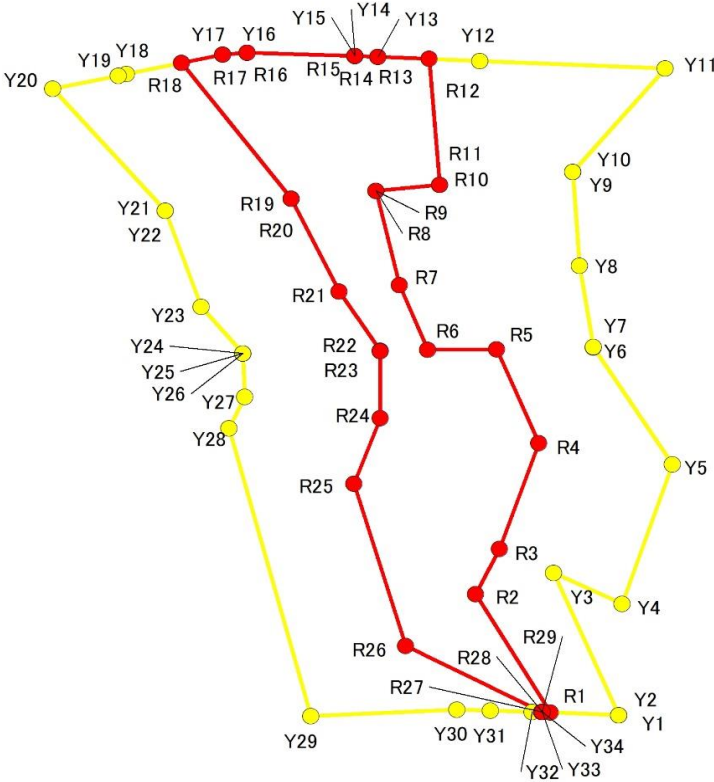
1:1,000

平面直角座標系：第Ⅸ区系(測地成果2011)
