急傾斜地の崩壊区域調査

様式5-4 危害のおそれのある土地等の座標位置図

II-061K2424-1

東和田6

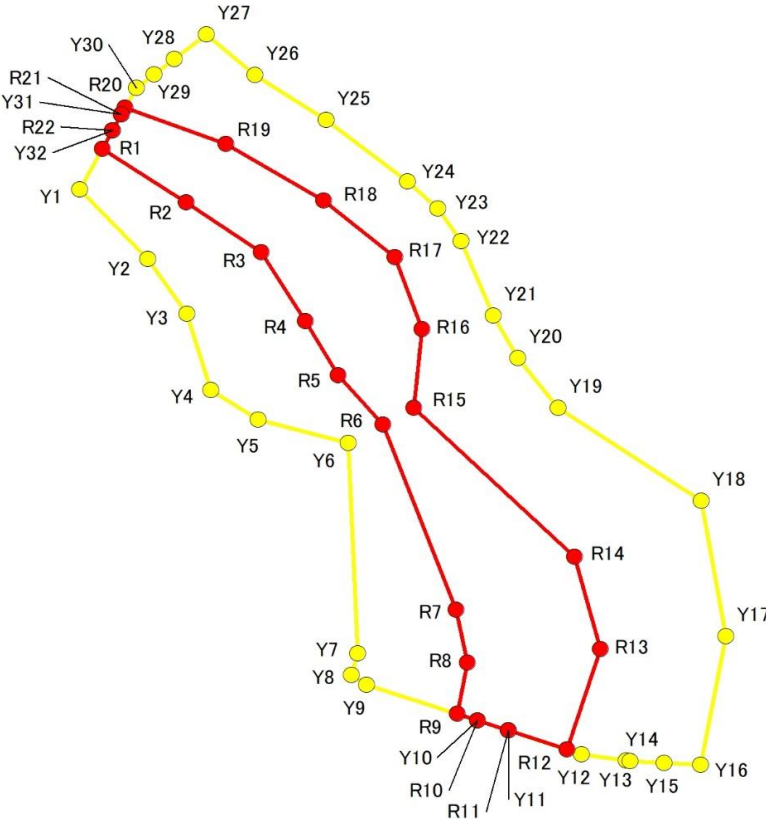
1:1,000
