# 急傾斜地の崩壊区域調書

様式5-4 危害のおそれのある土地等の座標位置図

II-064K2081

殿部田7

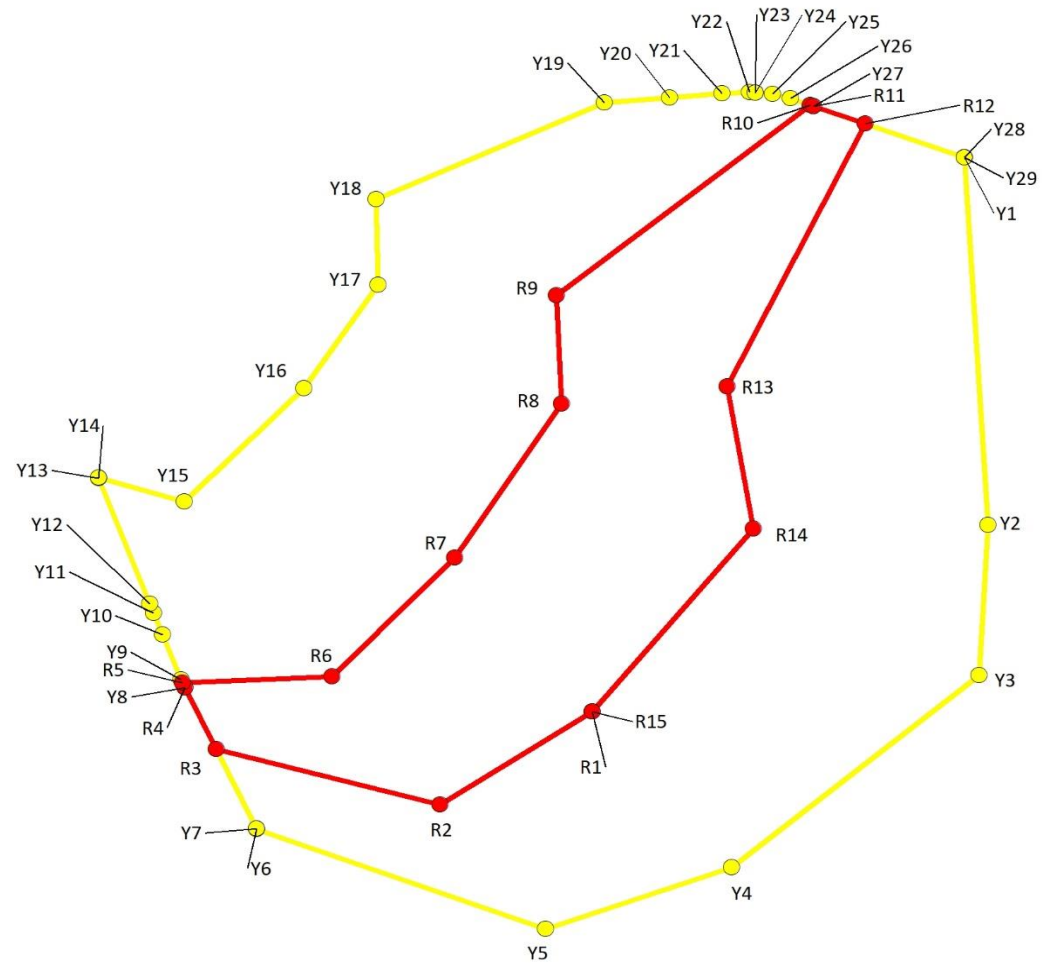
1:500

様式5-5 危害のおそれのある土地の座標一覧

平面直角座標系: 第Ⅸ系(測地成果2011)
