急傾斜地の崩壊区域調書

様式5-4 危害のおそれのある土地等の座標位置図

調査年度 2024

| 急傾斜地の位置 | 箇所番号 | II-121K2034-1 | | | | 箇所名 | 興津28 | | | | 所在地 | 勝浦市興津 | | |

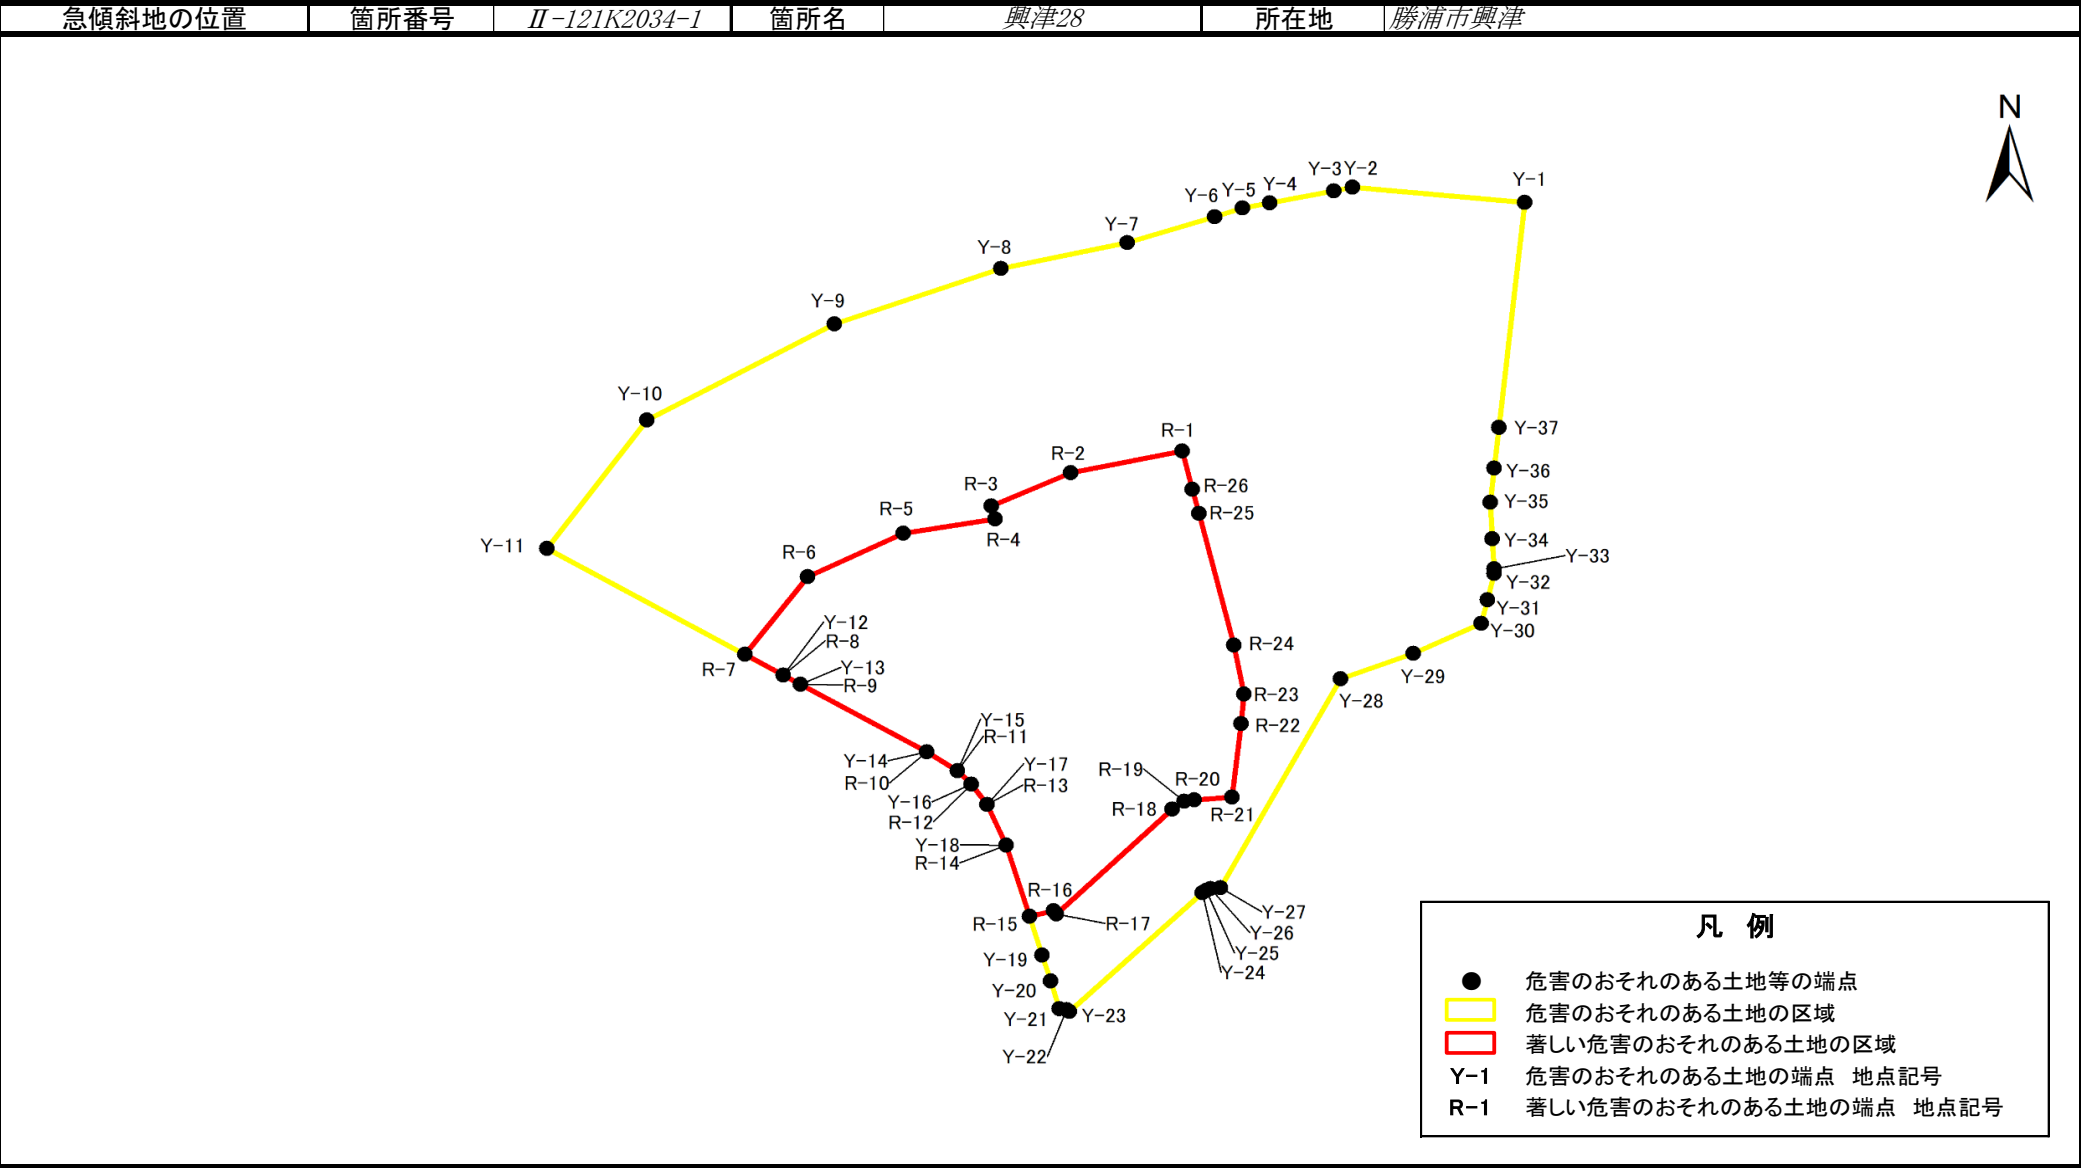
平面直角座標系：第Ⅸ区系(測地成果2011)

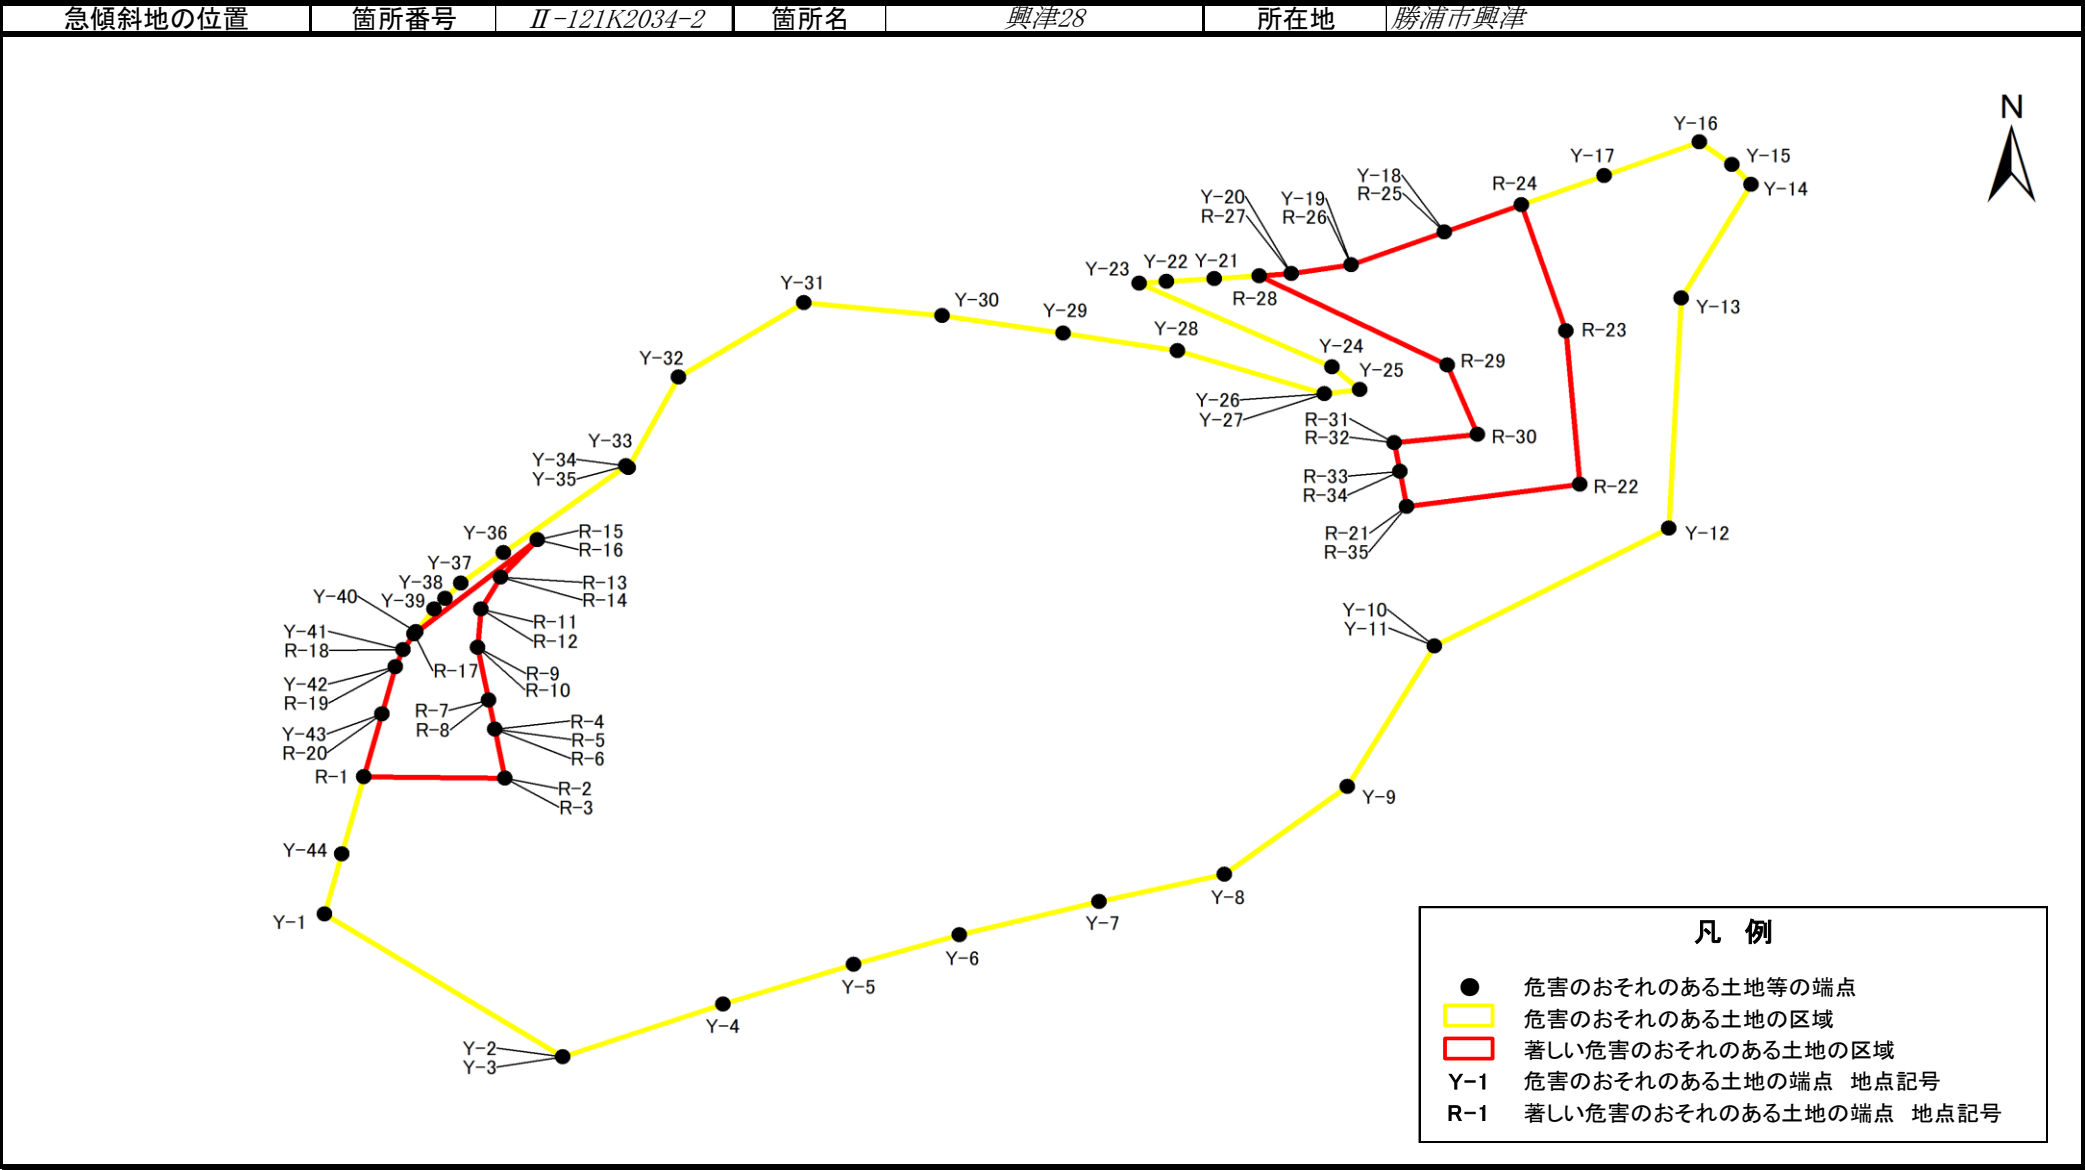
様式5-4 危害のおそれのある土地等の座標位置図

| 急傾斜地の位置 | 箇所番号 | II-121K2034-2 | 箇所名 | 興津28 | 所在地 | 勝浦市興津 | | | | | |

平面直角座標系：第Ⅸ区系(測地成果2011)

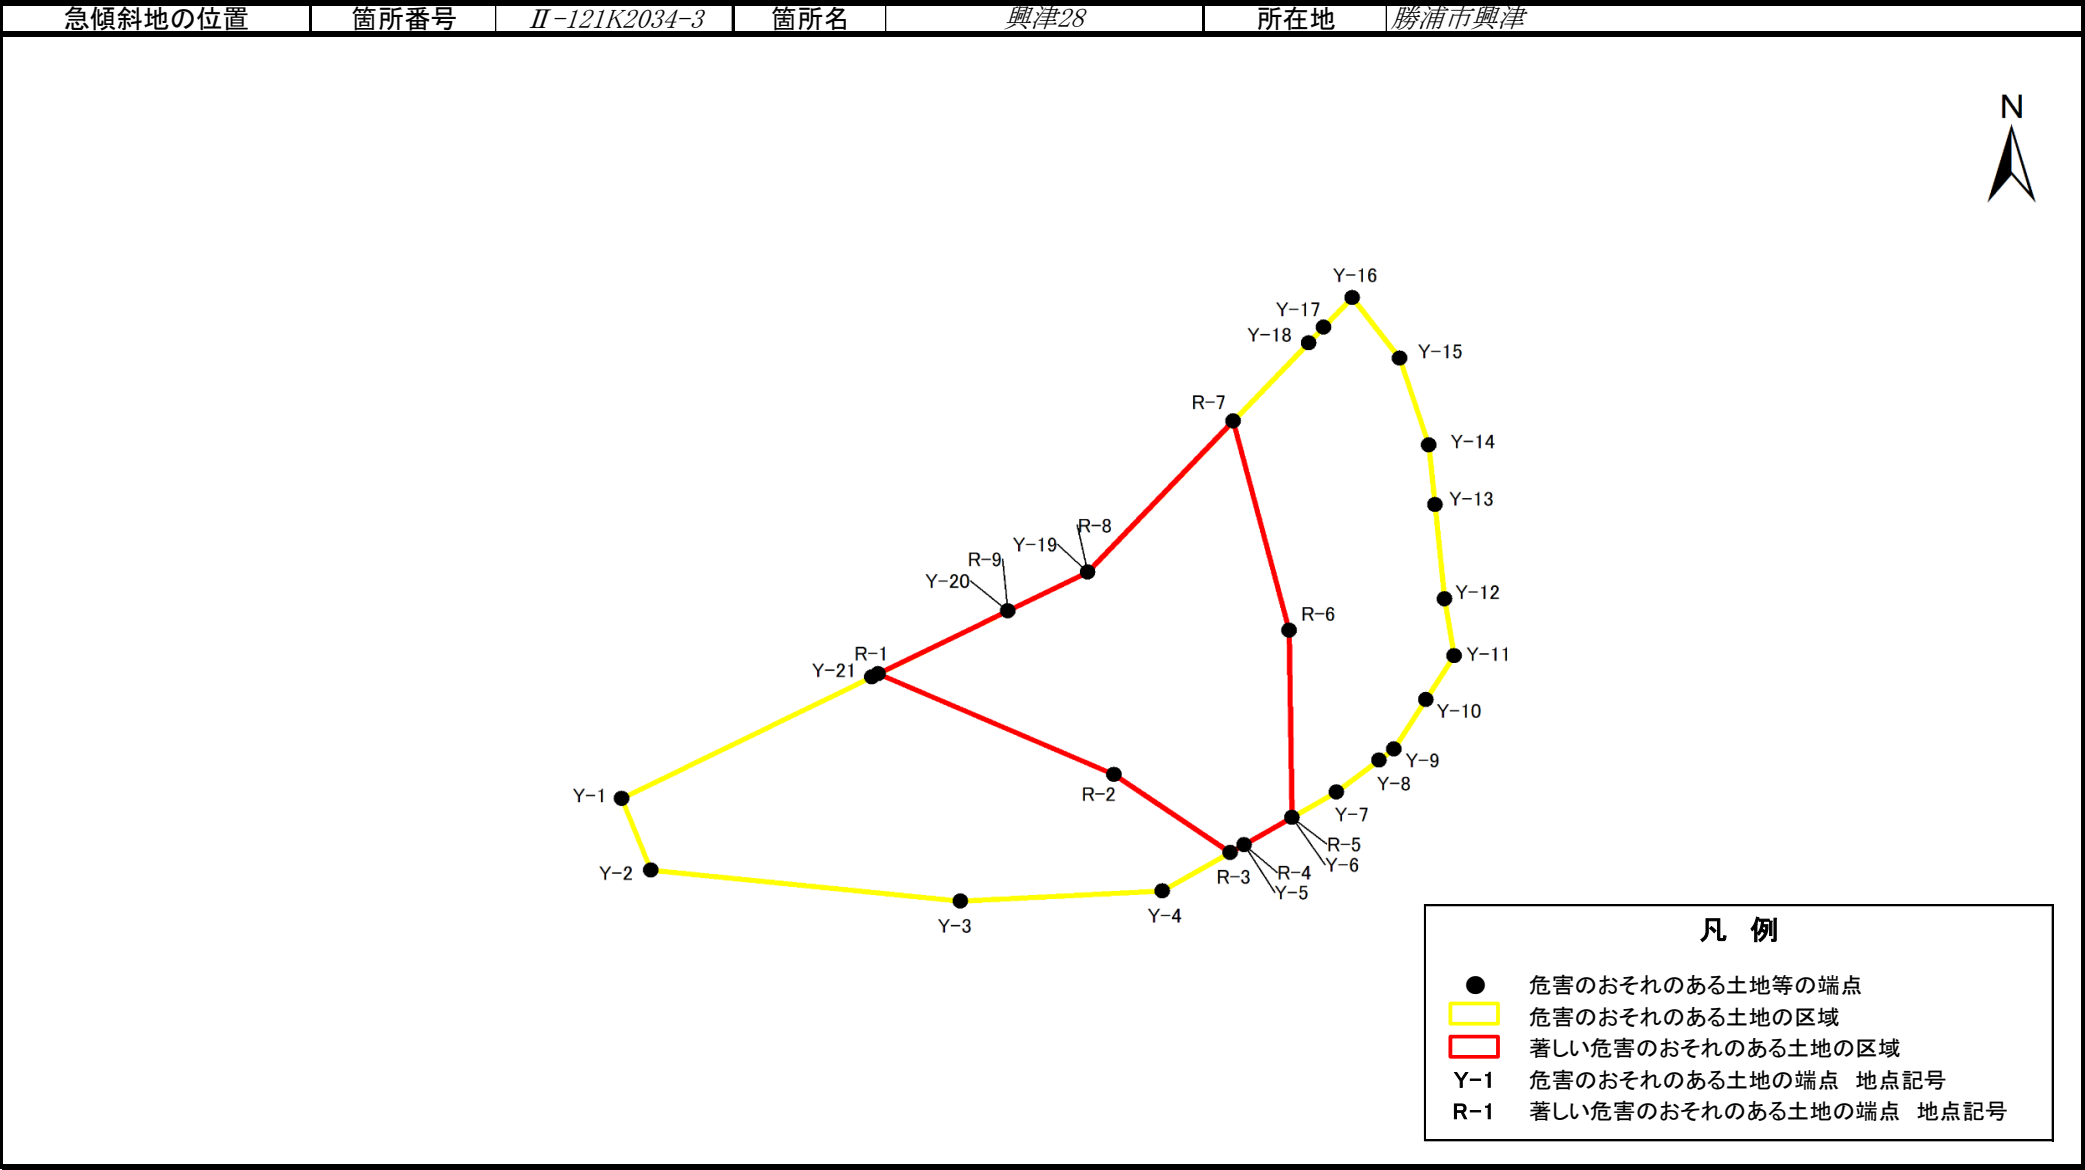
様式5-4 危害のおそれのある土地等の座標位置図

平面直角座標系：第Ⅸ系(測地成果2011)
