急傾斜地の崩壊区域調査

様式5-4 危害のおそれのある土地等の座標位置図

II-122K2069

下原5

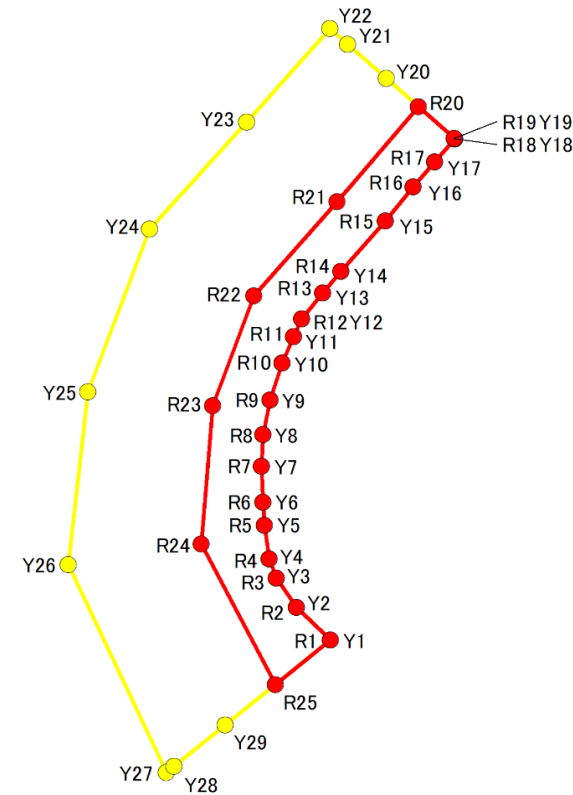
1:1,000

平面直角座標系：第Ⅸ区系(測地成果2011)

様式5-5 危害のおそれのある土地の座標一覧
