急傾斜地の崩壊区域調書

様式5-4 危害のおそれのある土地等の座標位置図

Ⅱ-122K2219

山田107

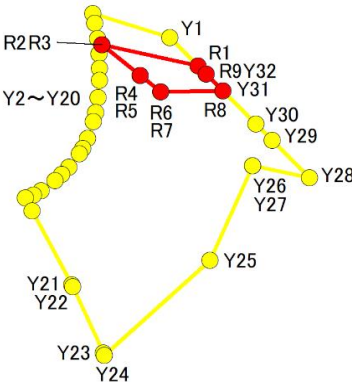
1:1,000
