# 急傾斜地の崩壊区域調査

様式5-4 危害のおそれのある土地等の座標位置図

Ⅱ-122K2312

新田野17

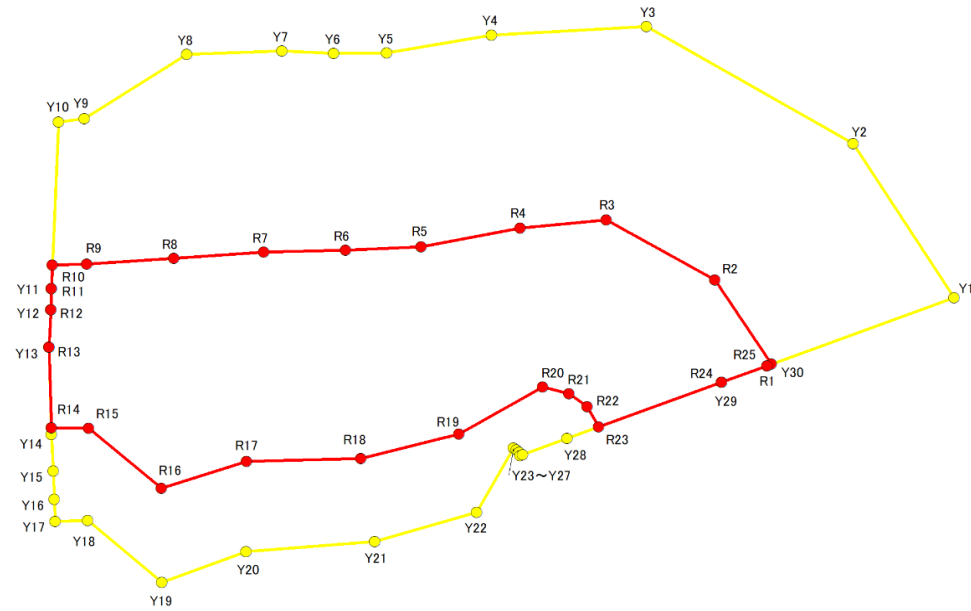
1:1,500

様式5-5 危害のおそれのある土地の座標一覧
