急傾斜地の崩壊区域調査

様式5-4 危害のおそれのある土地等の座標位置図

| 急傾斜地の位置 | 箇所番号 | II-1231 | 箇所名 | 用草2 | 所在地 | 八街市用草 |

様式5ー5 危害のおそれのある土地等の座標一覧

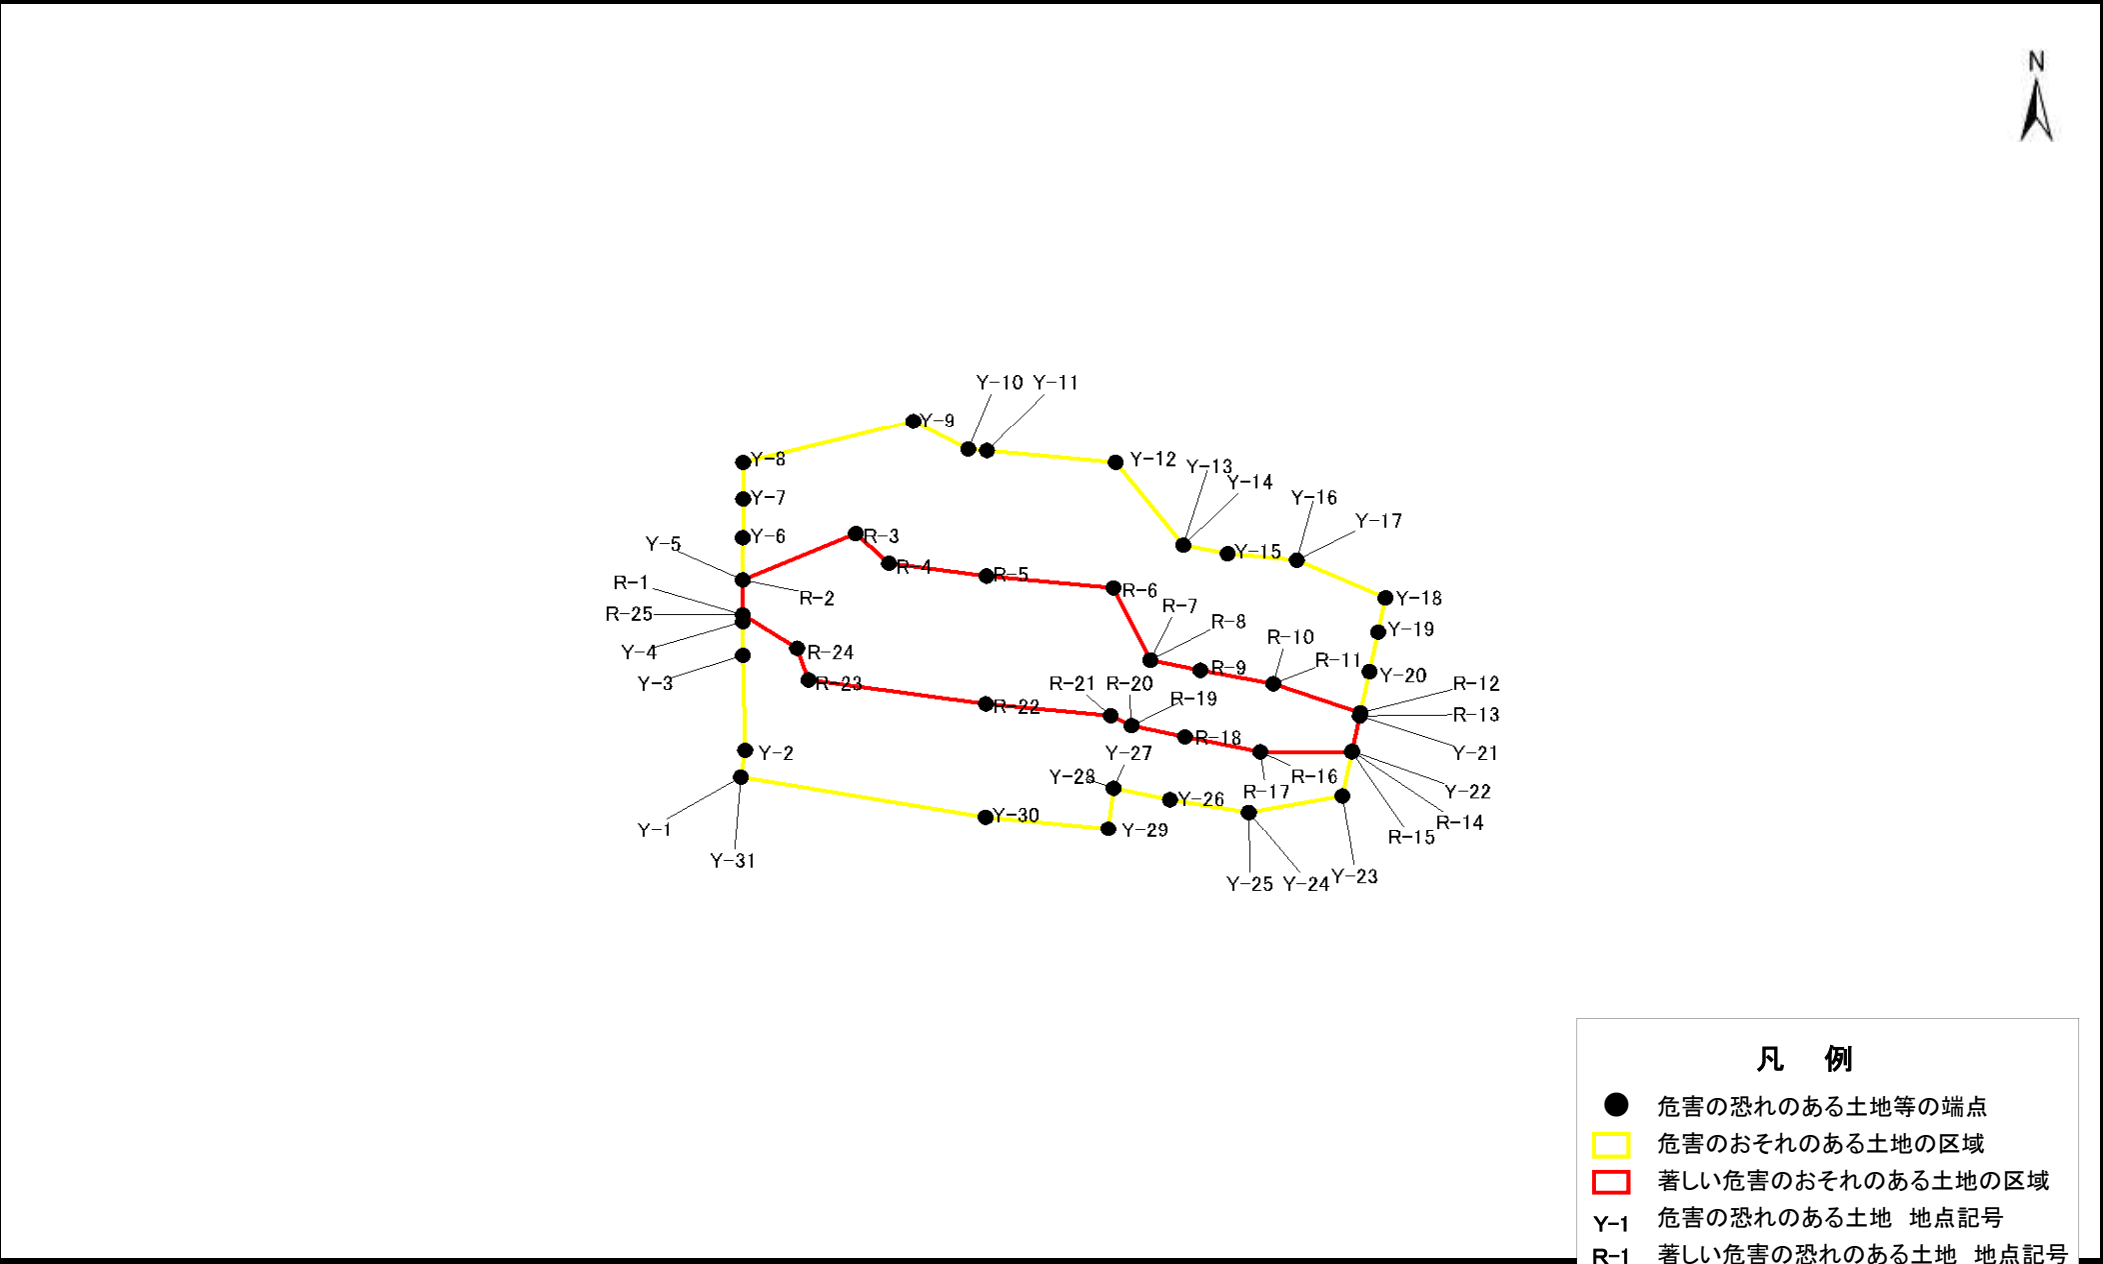
- 危害の恐れのある土地等の端点
- 危害のおそれのある土地の区域
- 著しい危害のおそれのある土地の区域
- Y-1 危害の恐れのある土地 地点記号
- R-1 著しい危害の恐れのある土地 地点記号
