# 急傾斜地の崩壊区域調査

様式5-4 危害のおそれのある土地等の座標位置図

II-123K2006

粟又25

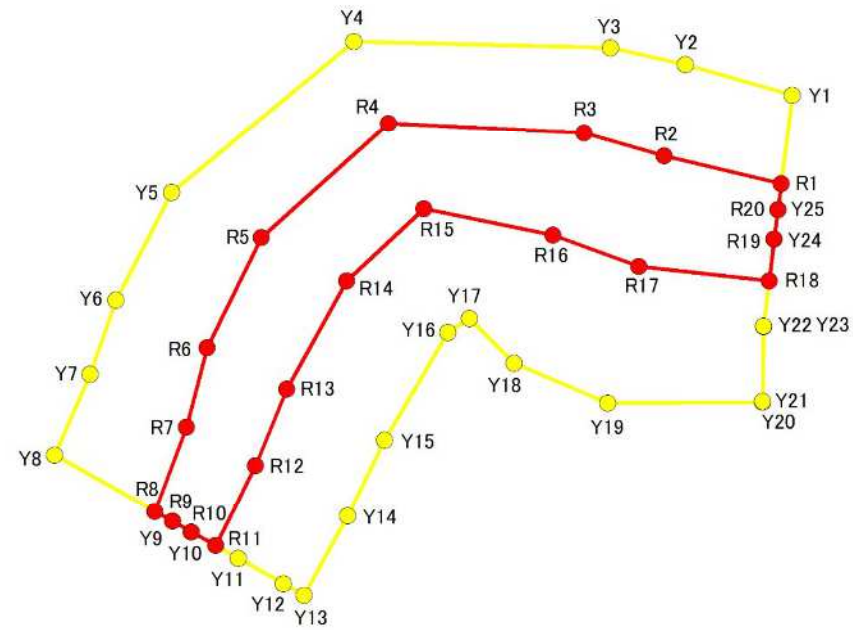
急傾斜地の位置

夷隅郡大多喜町粟又

1:1,000
