# 急傾斜地の崩壊区域調査

様式5-4 危害のおそれのある土地等の座標位置図

Ⅱ-123K2166-1

夷隅郡大多喜町田代

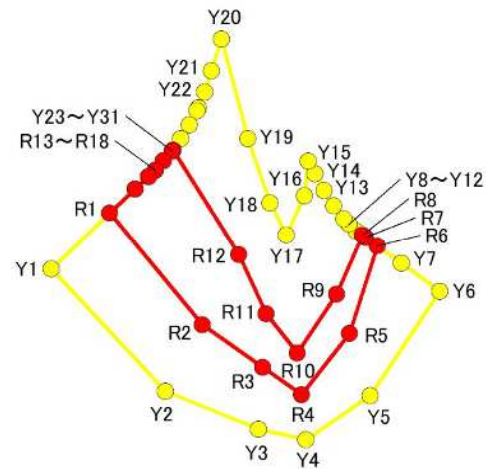
1:1,000
