# 急傾斜地の崩壊区域調査

様式5-4 危害のおそれのある土地等の座標位置図

II-132K2166

上小原2

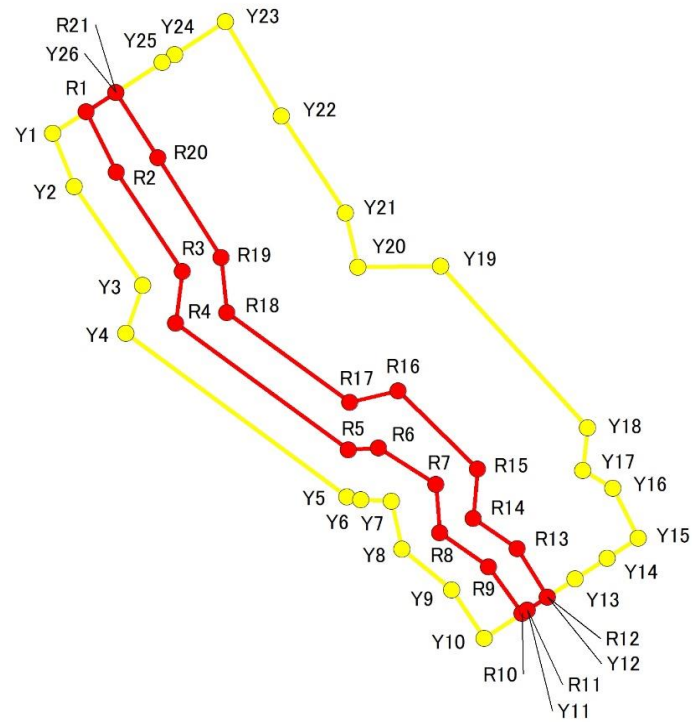
1:1,000

様式5-5 危害のおそれのある土地の座標一覧

| 危害のおそれのある区域の座標(土砂災害警戒区域) | | | | | | 著しい危害のおそれのある区域の座標(土砂災害特別警戒区域) | | | | | |

平面直角座標系：第Ⅸ区系(測地成果2011)
