急傾斜地の崩壊区域調査

様式5-4 危害のおそれのある土地等の座標位置図

II-132K2258

鴨川市代

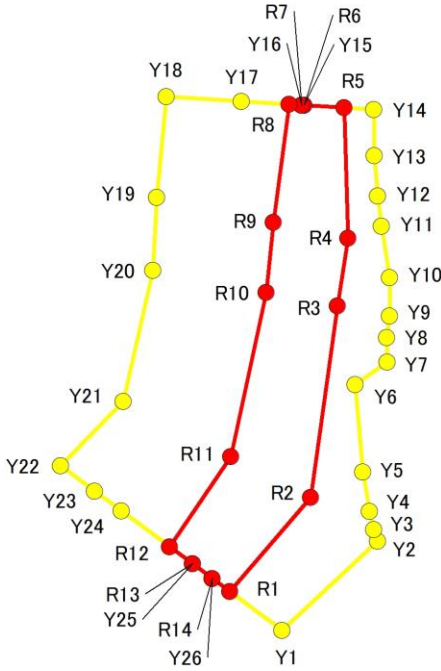
1:1,000

様式5-5 危害のおそれのある土地の座標一覧

平面直角座標系：第Ⅱ区系(測地成果2011)
